Spot Safety Project Evaluation

Project Log # 200501227

Spot Safety Project # 04-99-219

**Spot Safety Project Evaluation of the Flashing Traffic Signal Installation at the Intersection of
NC 210 and SR 1330 (Raleigh Rd) in Johnston County**

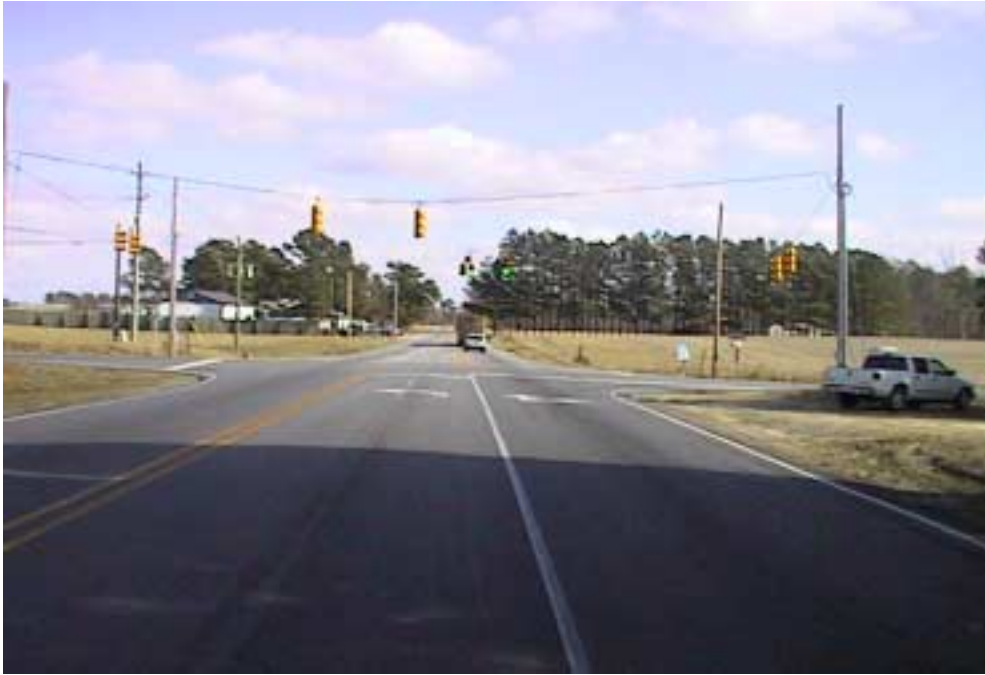
Facing East

There were 9 angle crashes that occurred during the before and after period including 1 Fatal crash. Out of the 9 angle crashes, 7 of them involved vehicles traveling west on NC 210. Referencing the included pictures there is no current sight distance problem looking at the east approach from either the north or south direction. However, from the data provided it cannot be ruled out that there may have been a sight distance problem in the before and after periods. The pictures also show that the intersection has a 90-degree orientation so drivers should not have difficulty recognizing the stop condition.
